TECHNICAL ASSISTANCE TEAM FOR EMERGENCY RESPONSE REMOVAL AND PREVENTION  
EPA CONTRACT 68-01-7367

September 5, 1989

Re: Albion - Sheridan Township Landfill, Albion, Michigan,  
TDD#5-8907-33

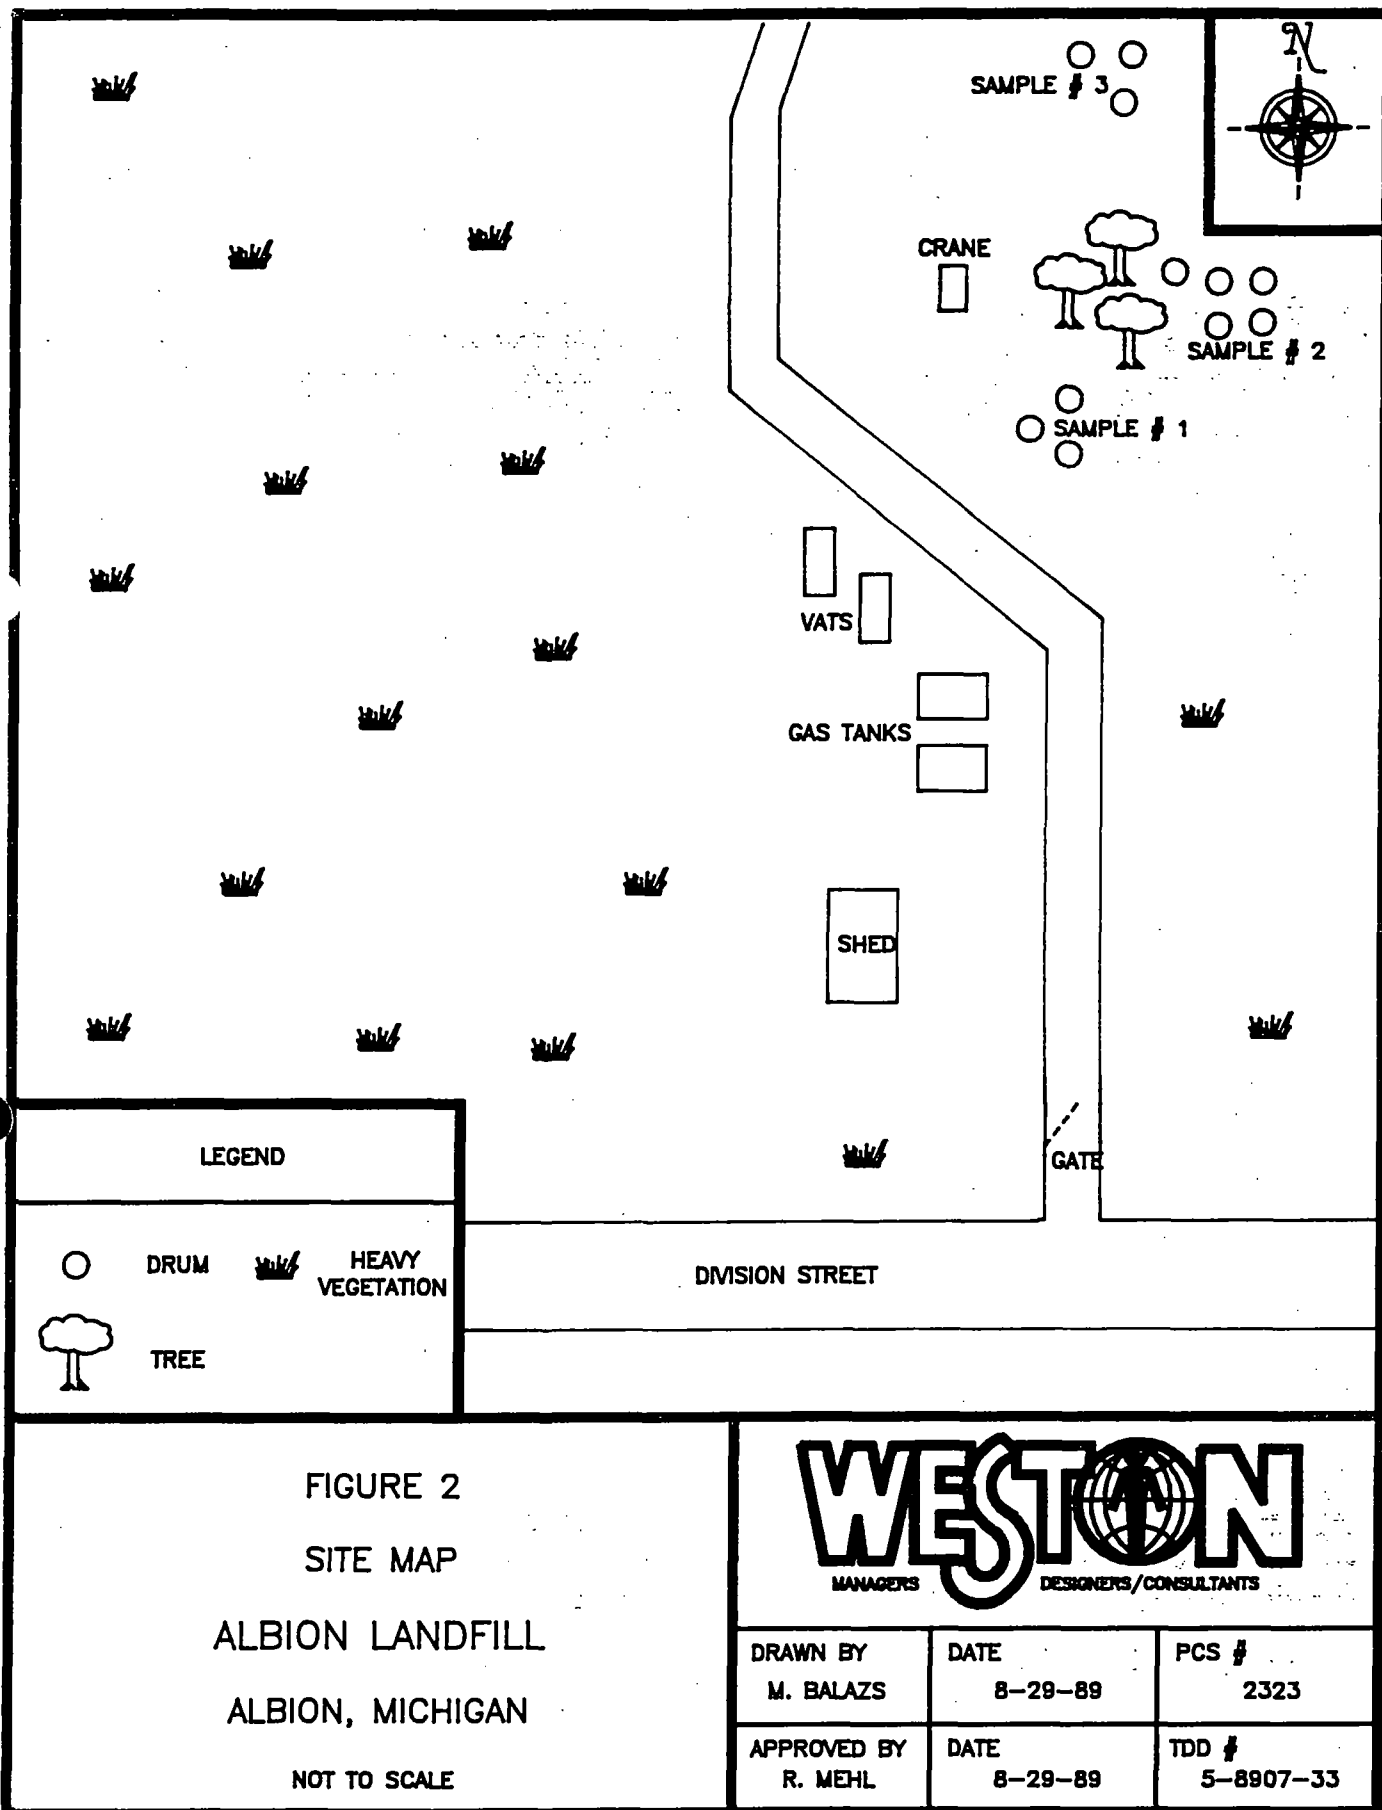
The TAT collected two drum and one sludge sample from various areas of the site (Figure 2). Sample #1 was grease-like material from a drum labeled as industrial grease; Sample #2, was a hard paint-sludge material from an unlabeled drum; and Sample #3 was a grease-like material that was spread on the ground. The samples were analyzed for Resource Conservation and Recovery Act (RCRA) parameters, under TAT Analytical Services TDD# 5-8908-L5.

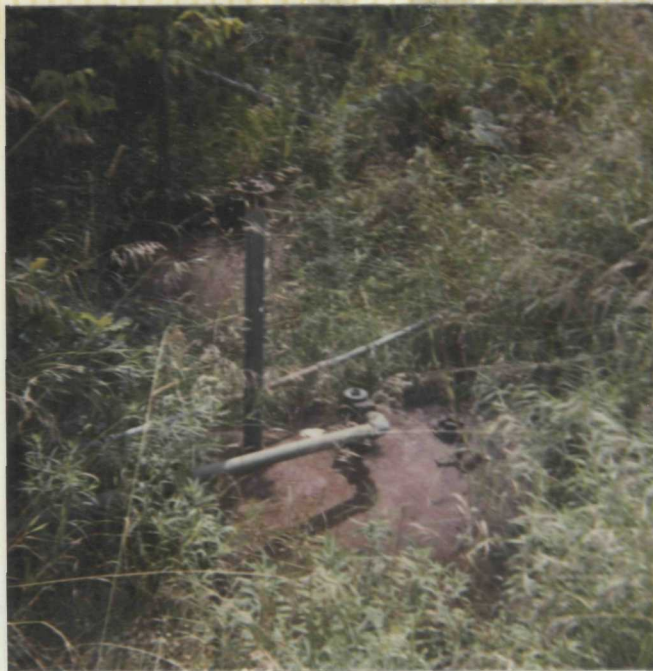
PHOTO: 1  
 SITE: ALBION LANDFILL  
 DESCRIPTION: UNDERGROUND TANK  
 DATE/TIME: AUGUST 15, 1989/1330  
 PHOTOGRAPHER: R. MEHL *RM*

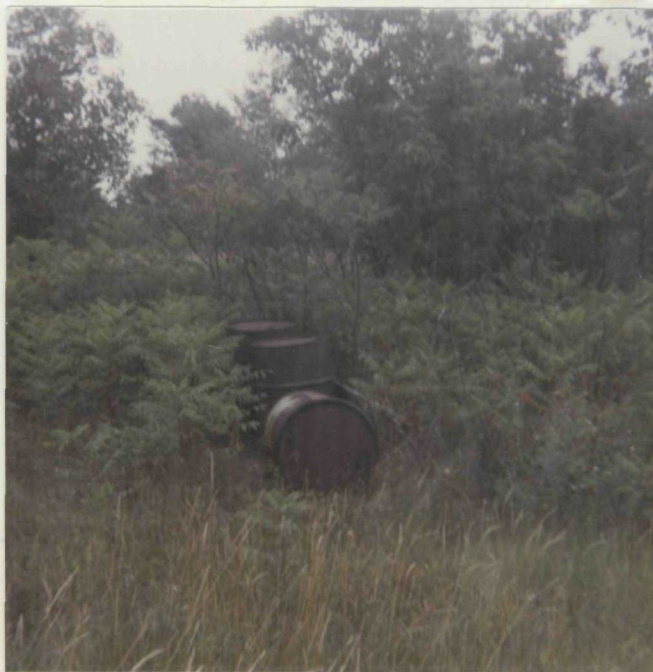
PHOTO: 2  
 SITE: AL  
 DESCRIPTION: THREE EMPTY DRUMS  
 DATE/TIME: AUGUST 15, 1989/1335  
 PHOTOGRAPHER: R. MEHL *RM*

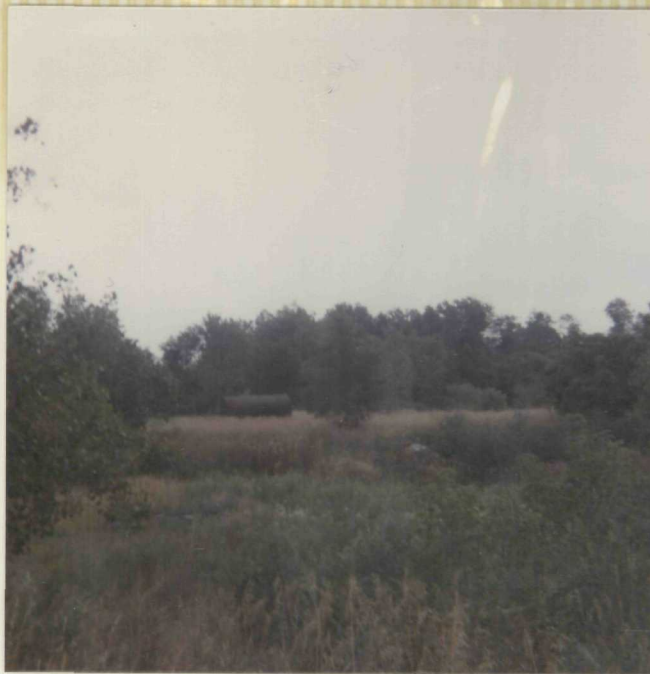
PHOTO: 3  
 SITE: AL  
 DESCRIPTION: EMPTY 5000 GAL TANK  
 DATE/TIME: AUGUST 15, 1989/1340  
 PHOTOGRAPHER: R. MEHL

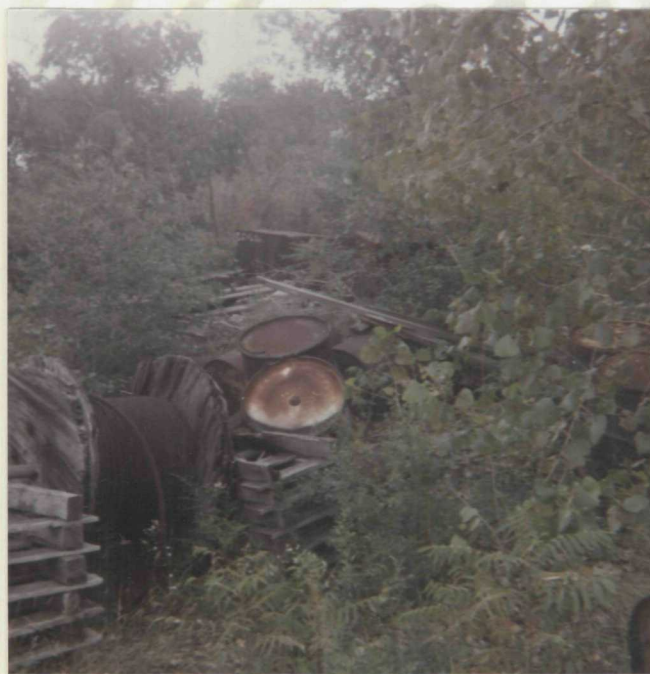
PHOTO: 4  
 SITE: AL  
 DESCRIPTION: DRUMS AND DEBRIS DUMPED HERE  
 DATE/TIME: AUGUST 15, 1989/1345  
 PHOTOGRAPHER: R. MEHL
